# Red Hook Water Storage Tank Engineering Report

Town of Red Hook Water District No. 1

August 24, 2022

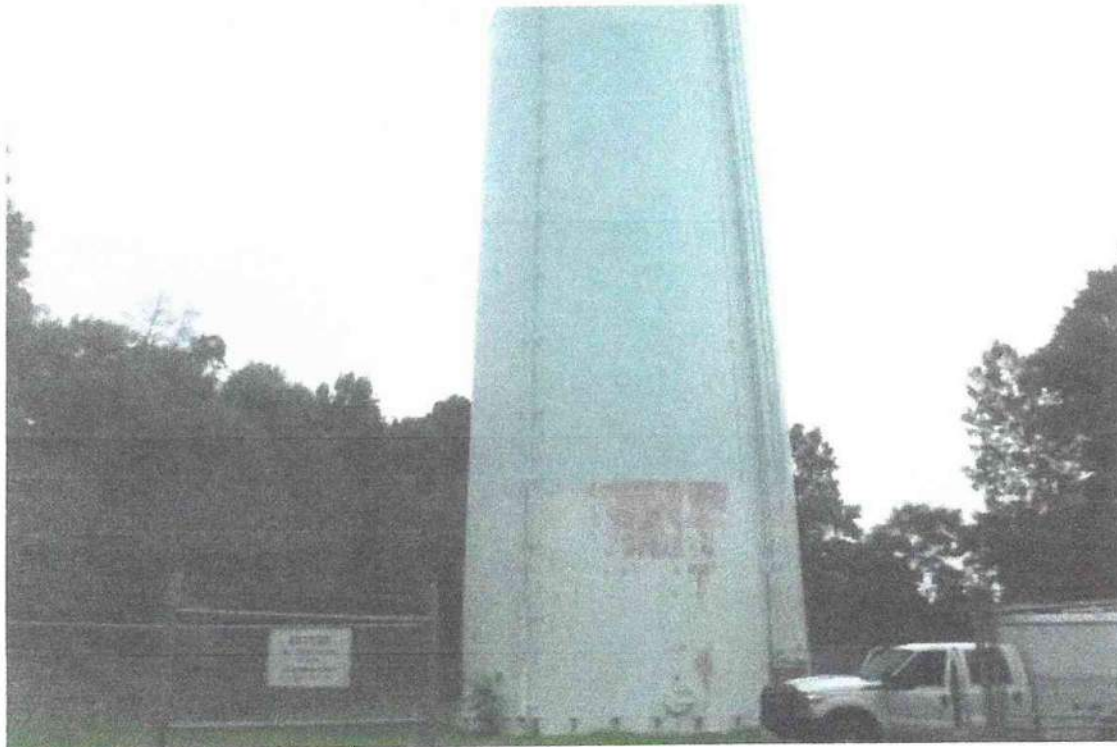
Photo shows the tank is secured with fencing. We recommend posting a **Warning, Tampering With This Facility is a Federal Offense** (US code title 42, section 300i-1) sign.

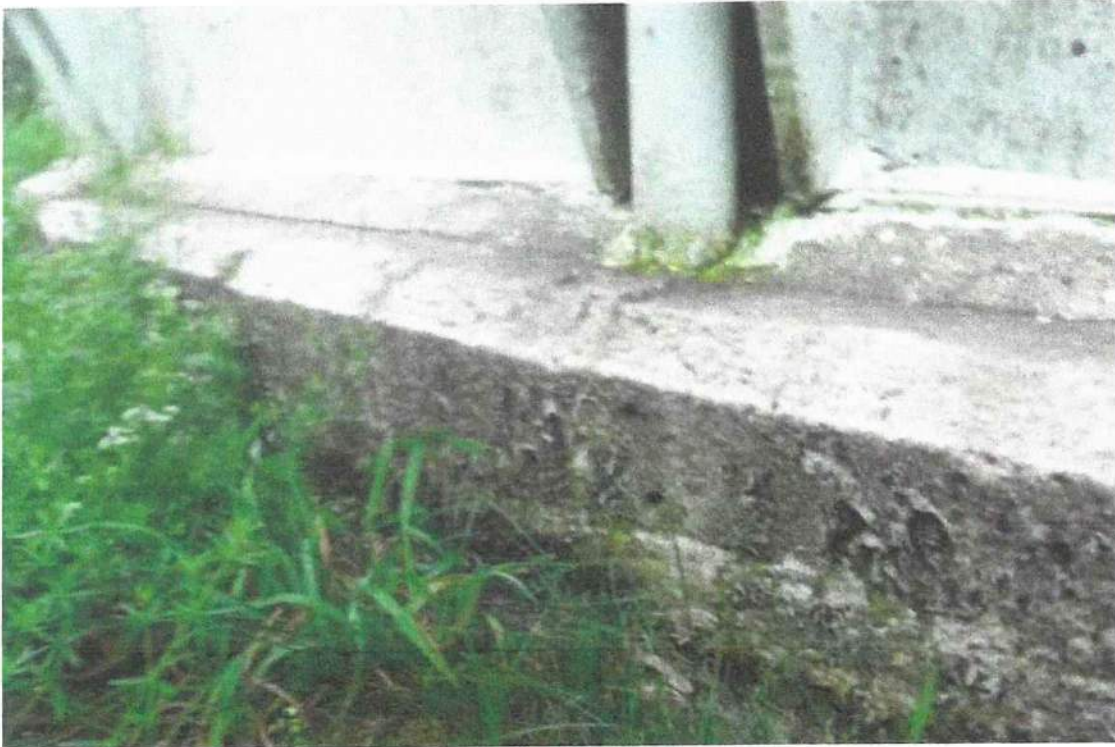
Photo shows the area around the tank foundation is properly graded and in compliance with **AWWA D100-11; 12.7.1: Height aboveground.**

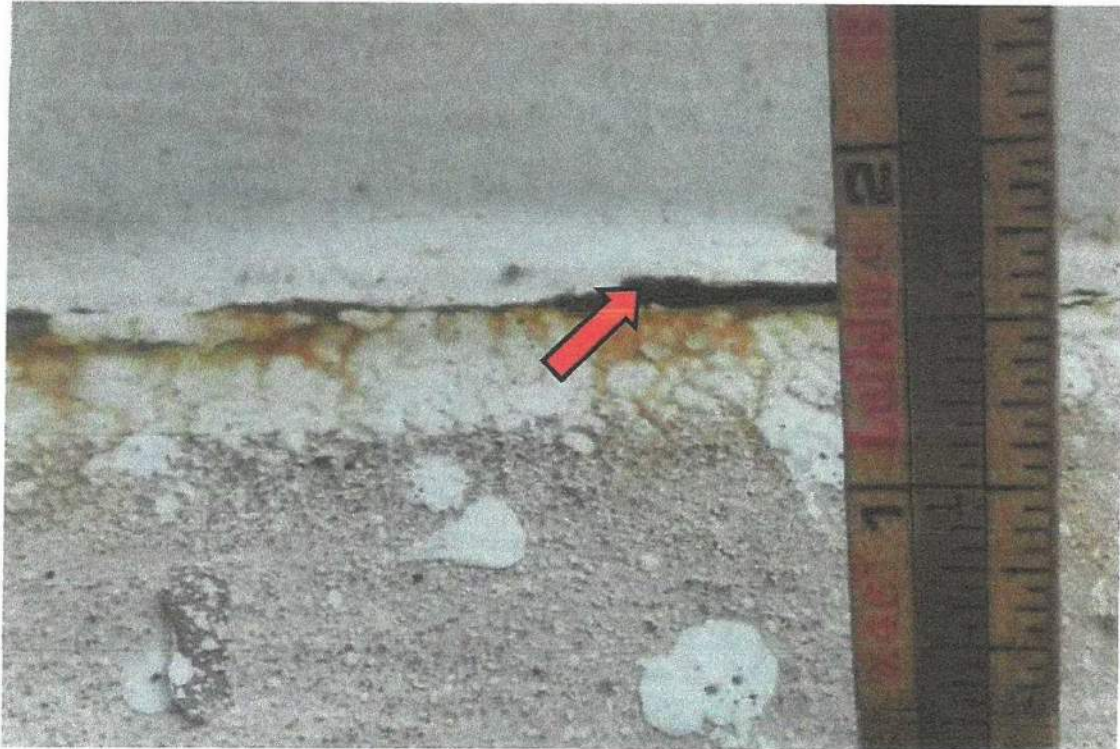
Photo shows the condition of the foundation. We recommend repairing any cracks and spalling in the concrete with a commercial non-shrinking grout, caulking around the base of the tank to foundation connection to prevent water from entering under the tank, then sealing the foundation with a sealant.

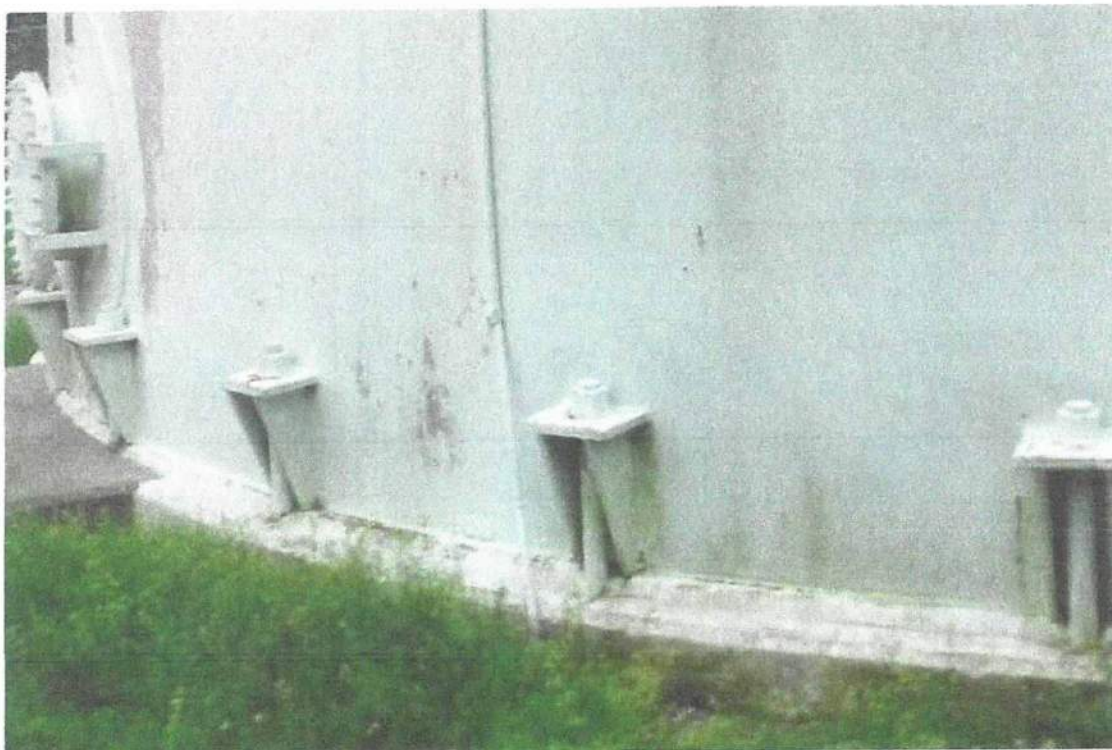
Photo shows the tank is electrically grounded for lightning protection as required by **OSHA 29 CFR 1926 (K)** and appears to be in good condition.

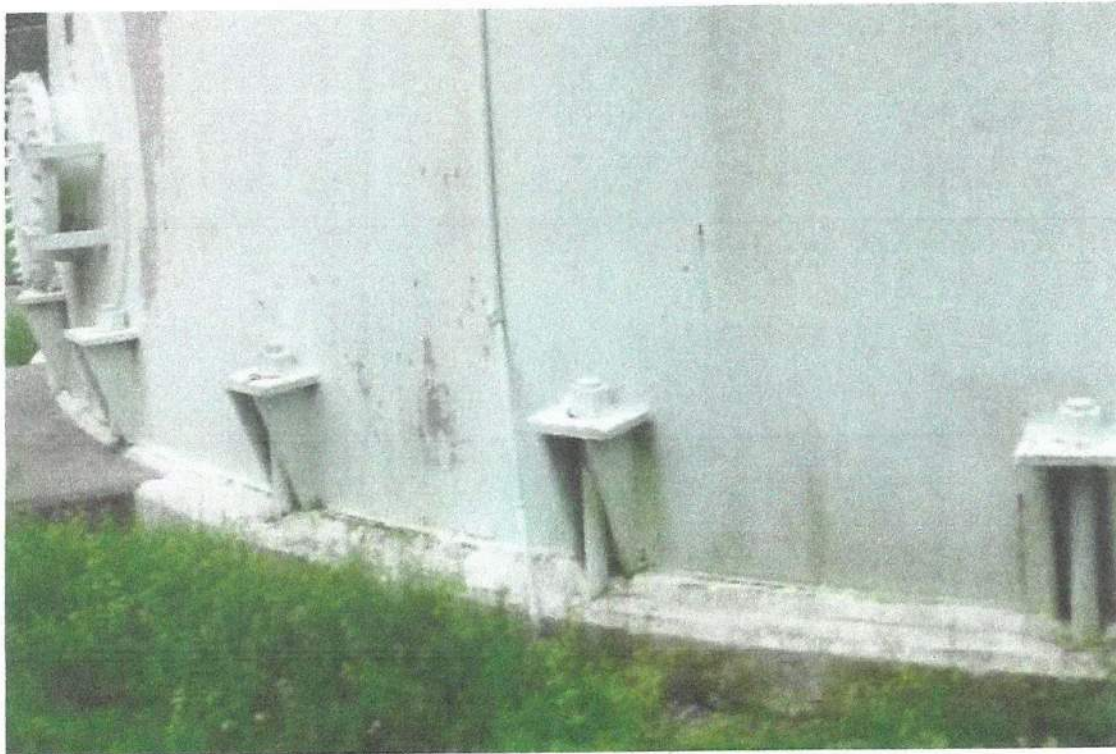
Photo shows the condition of the anchor bolts. **AWWA D100-11; 3.8.1.1: Required Anchorage** states, "For ground-supported flat-bottom reservoirs and standpipes, mechanical anchorage shall be provided when the wind or seismic loads exceed the limits for self-anchored tanks." We recommend cleaning the area around the anchor bolts, tightening the anchor nuts to specifications, then tack welding on the circumference of the nut-to-base plate connections and tack welding the bolt-to-nut connections for preventive maintenance.

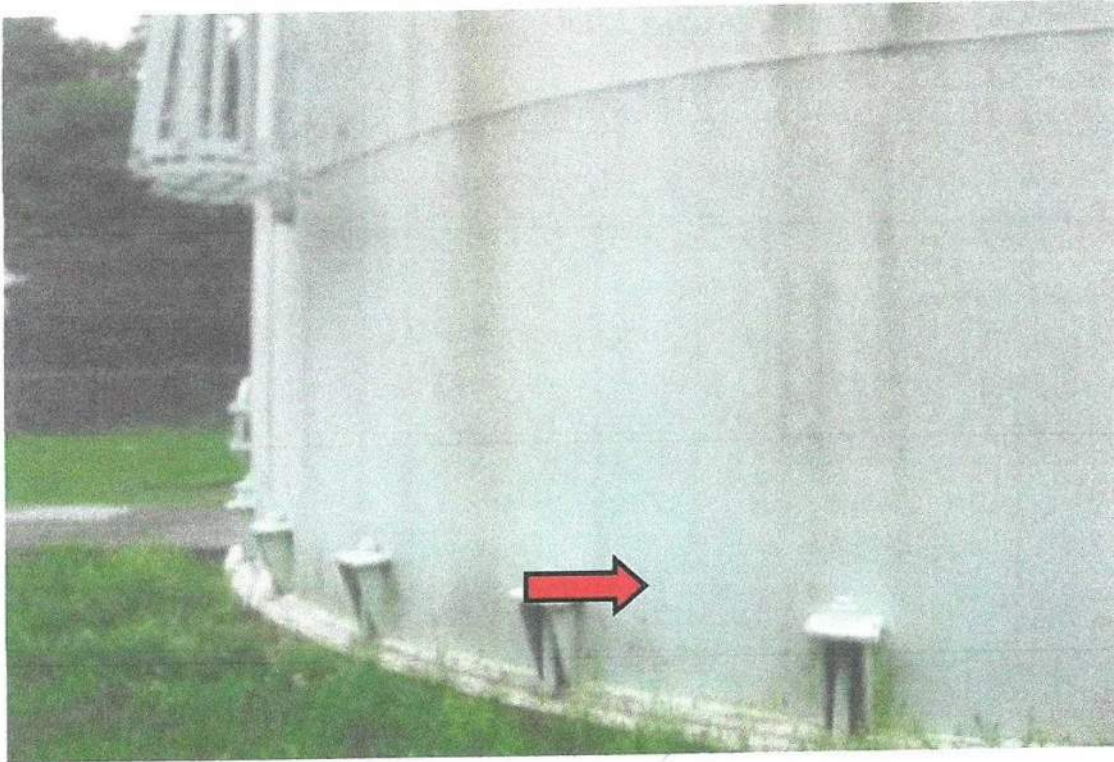
Photo shows the condition of the shell. Currently there is no drain valve. We recommend installing a frost proof drain valve near the shell-to-floor connection, complete with a locking device to prevent unauthorized draining of the tank and a splash pad to direct water away from the foundation.

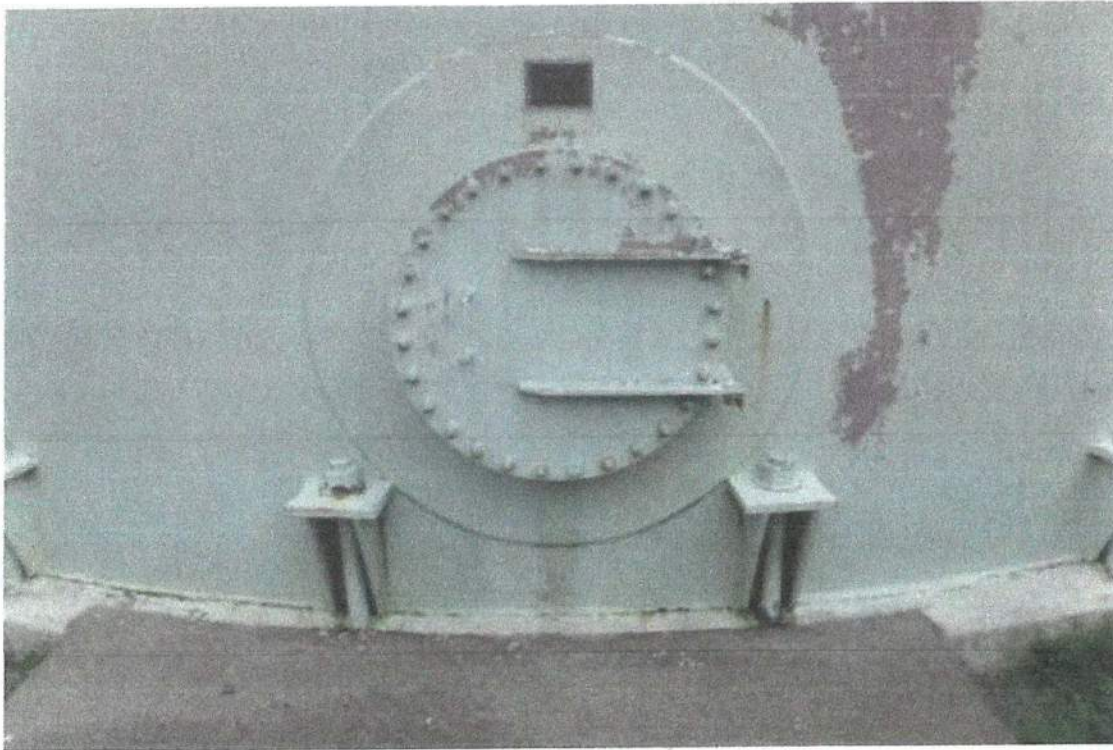
Photo shows the condition of the 30" primary shell manway. **AWWA D100-11; 7.4.4: Shell manholes** states, "Two shell manholes shall be provided in the first ring of the tank shell. At least one manhole shall be circular with a minimum diameter of 30" (760 mm)." The primary manway requires the following to be in compliance with **AWWA D100-11; 7.4.4: Shell manholes** and **OSHA 1910.146 (c)(2) Confined spaces**.

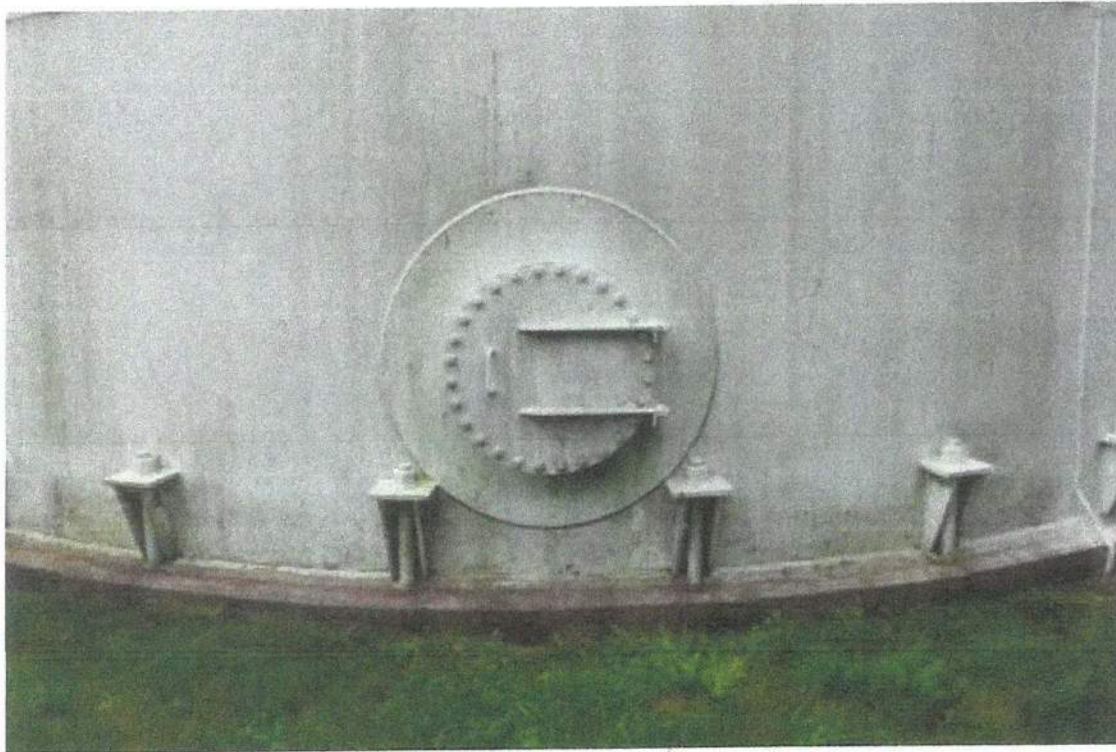
Photo shows the condition of the 30" secondary shell manway. **AWWA D100-11; 7.4.4: Shell manholes** states, "Two shell manholes shall be provided in the first ring of the tank shell. At least one manhole shall be circular with a minimum diameter of 30" (760 mm)." The secondary manway requires the following to be in compliance with **AWWA D100-11; 7.4.4: Shell manholes** and **OSHA 1910.146 (c)(2) Confined spaces**.

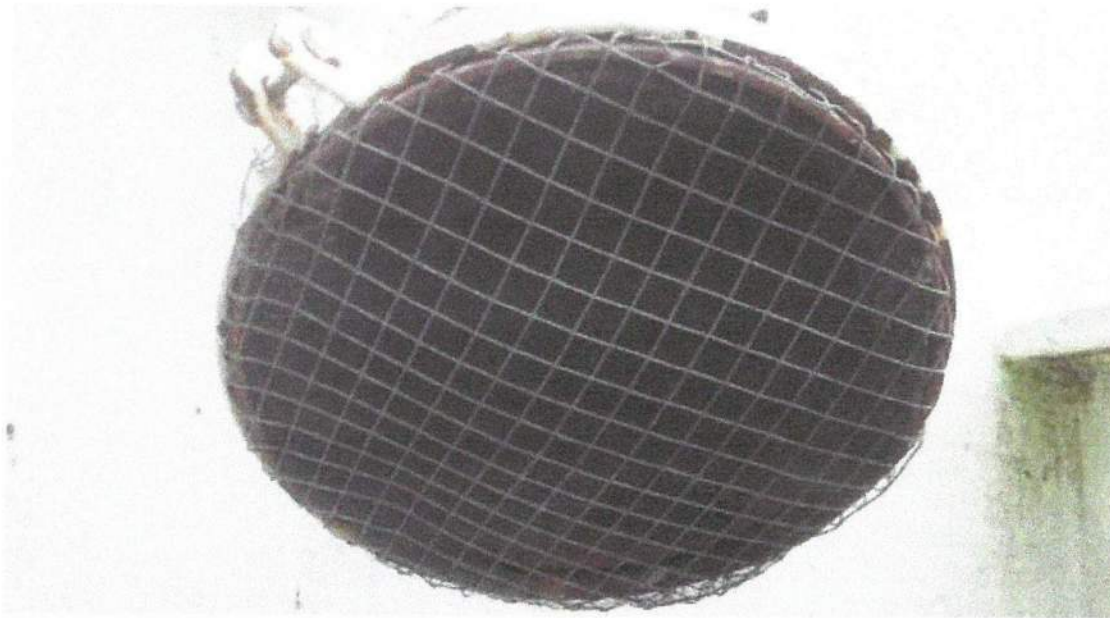
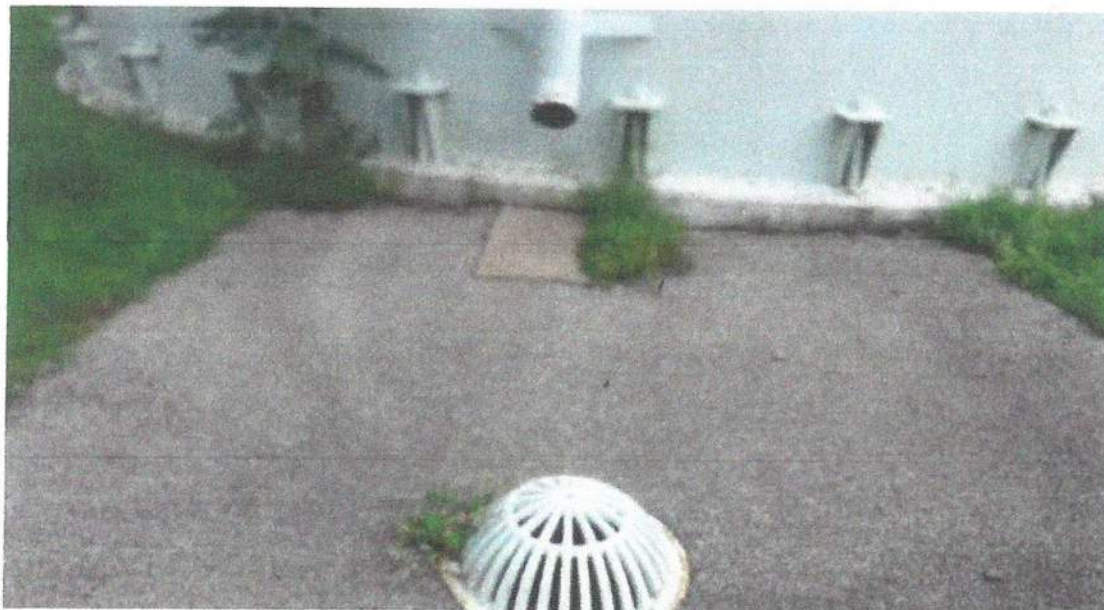
Photos show the overflow pipe system, which is not equipped with a flapper valve as required by [AWWA D100-11; 7.3: Overflow](#). We recommend installing a flapper valve and new screen on the existing overflow pipe.

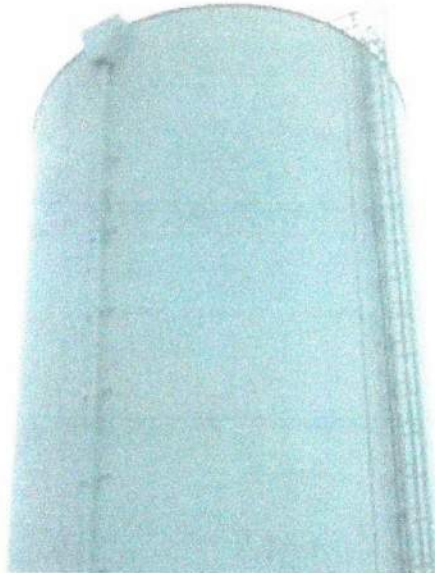
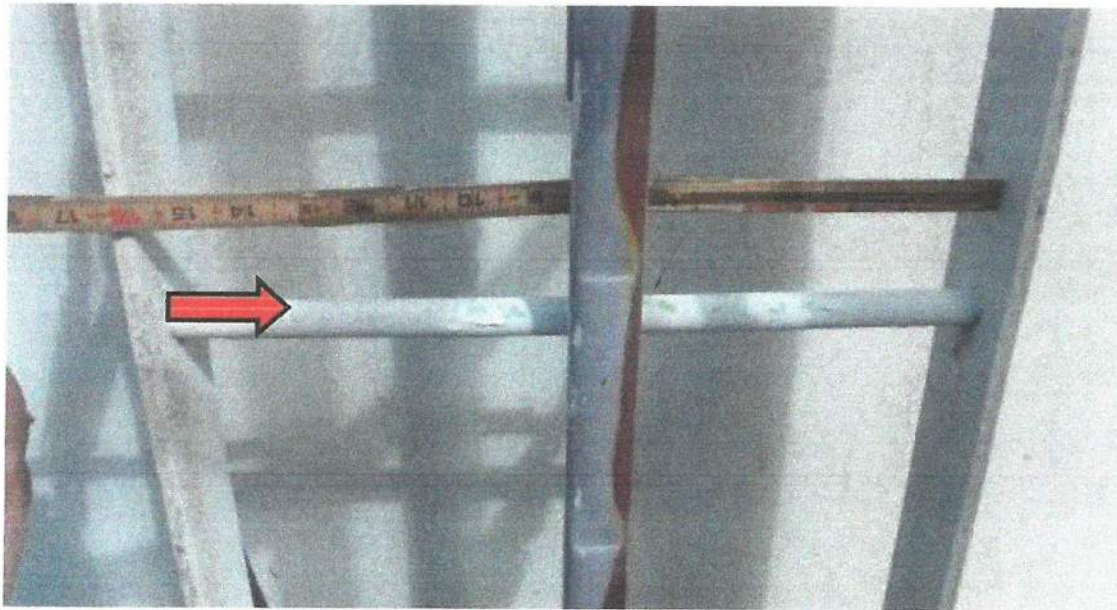
Shell access ladder in above photos is 16" wide, but is not equipped with anti-skid rungs. **Notice the condition of the safety climb.** OSHA 1926.1053 Ladders states, "Rungs must be corrugated, knurled, dimpled, coated with skid-resistant material or treated to minimize slipping." We recommend installing anti-skid rung covers, replacing the existing safety climb with a cable type ladder safety device, and posting a **Fall Protection Required** sign at the base of the ladder.

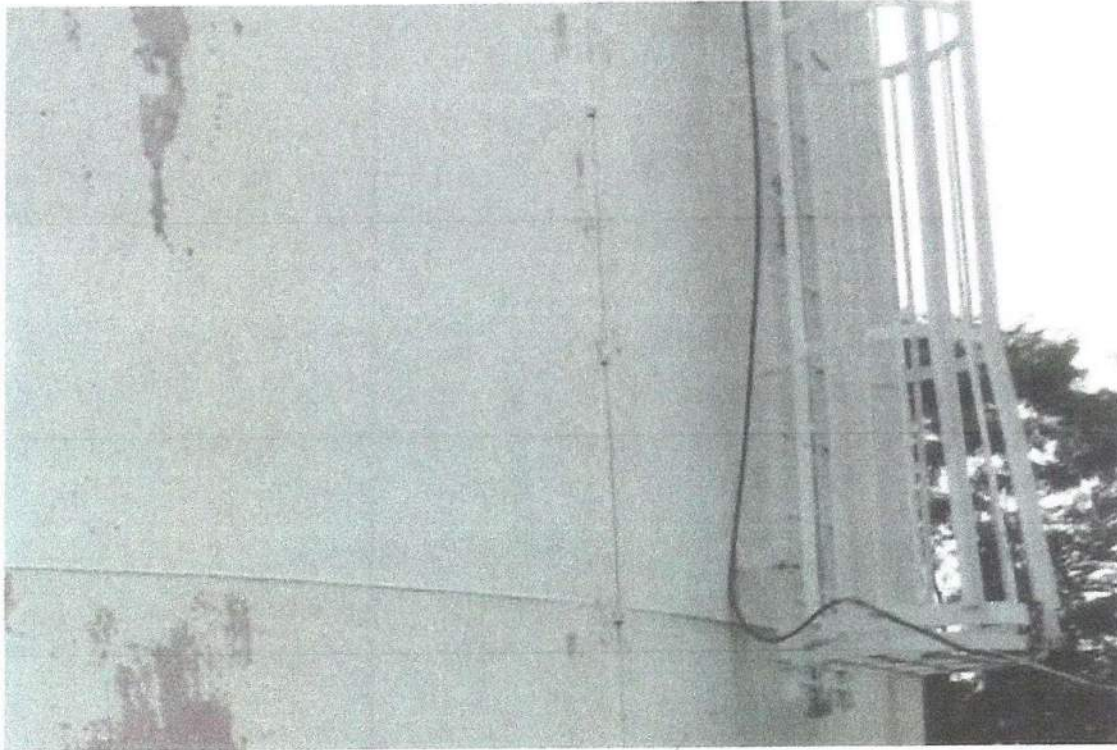
Photo shows more of the condition of the existing shell access ladder. Safe climbing procedure requires a person to climb a ladder with their hands on the side rails of the ladder and not the ladder rungs. **Notice a co/ax is mounted on the ladder side rail, creating a climbing safety hazard.** We recommend removing the co/ax from the ladder, and securing it with standoffs to the tank shell to eliminate this climbing safety hazard.

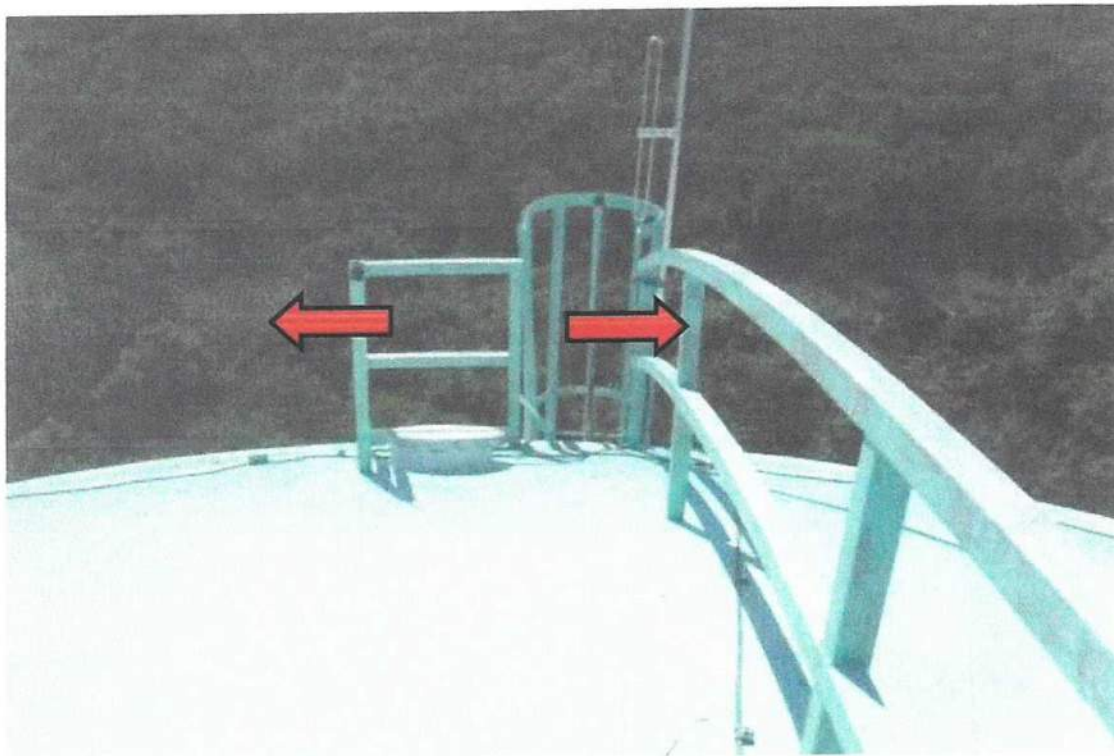
Photo shows the tank roof edge is not equipped with a required handrail system for fall protection. **OSHA 1910.23 (c)(1)** states, "Every open-sided floor or platform 4 feet or more above adjacent floor or ground level shall be guarded by a standard railing... on all open sides." The tank is equipped with 42" high handrails to the left and right of the access ladder. We recommend extending the handrails around the circumference of the tank roof, complete with an intermediate rail, a toeboard, and a swing gate at the junction of the shell-to-roof access ladder and tank roof.

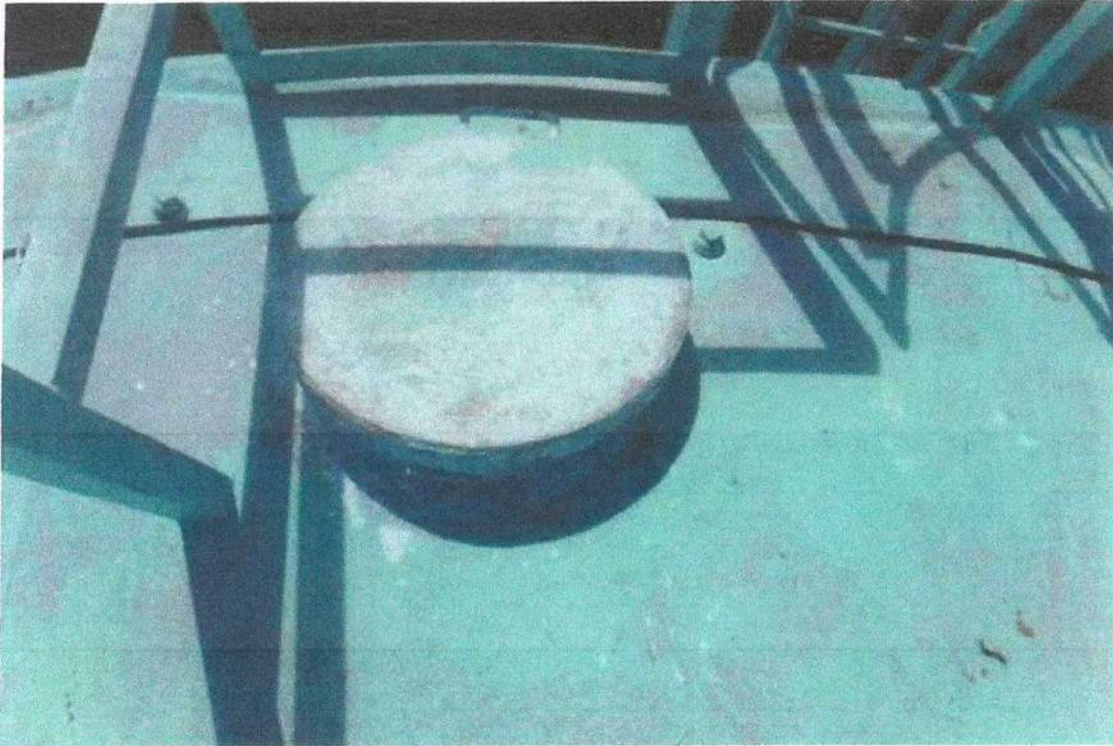
Photo shows the condition of the 24" primary roof manway. Roof openings on this tank require the following to be in compliance with **AWWA D100-11, 7.4.3: Roof openings** and **OSHA 1910.146 (c)(2) Confined spaces**.

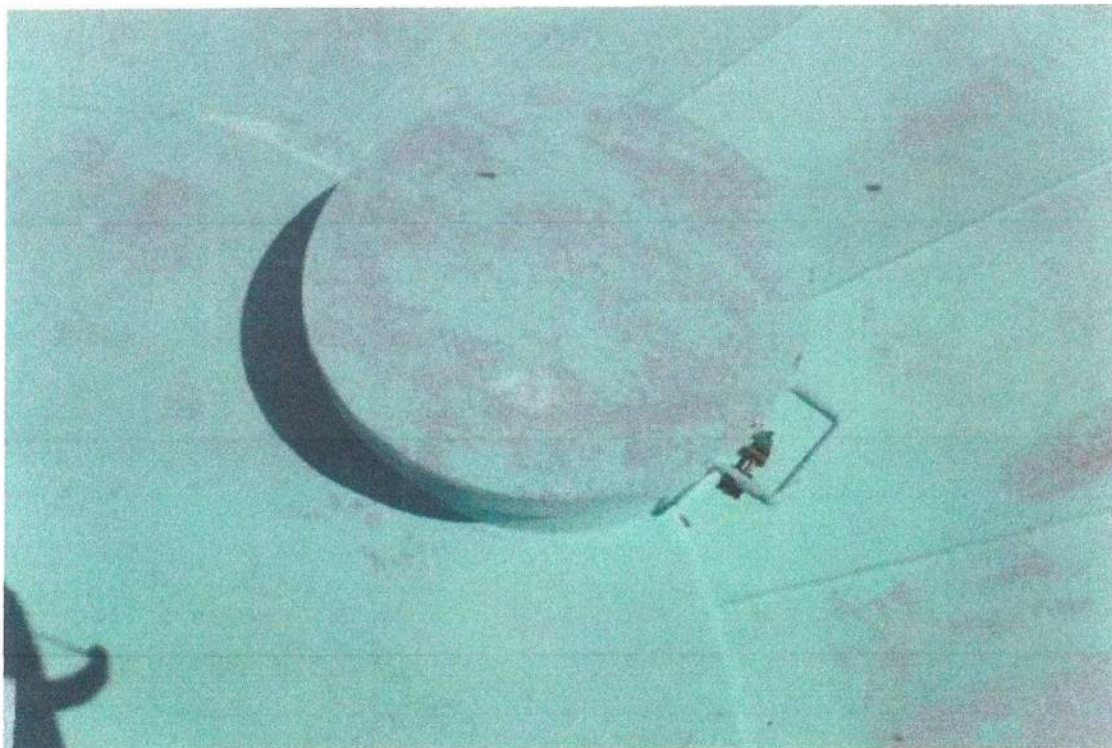
Photo shows the condition of the 24" secondary roof manway. Roof openings on this tank require the following to be in compliance with **AWWA D100-11, 7.4.3: Roof openings** and **OSHA 1910.146 (c)(2) Confined spaces**.

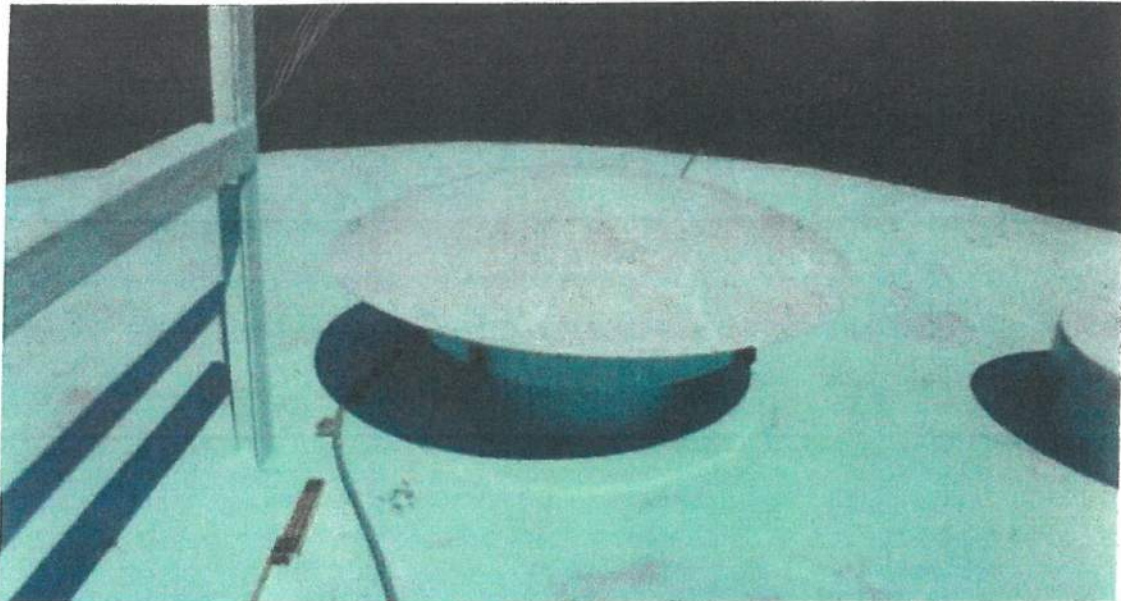
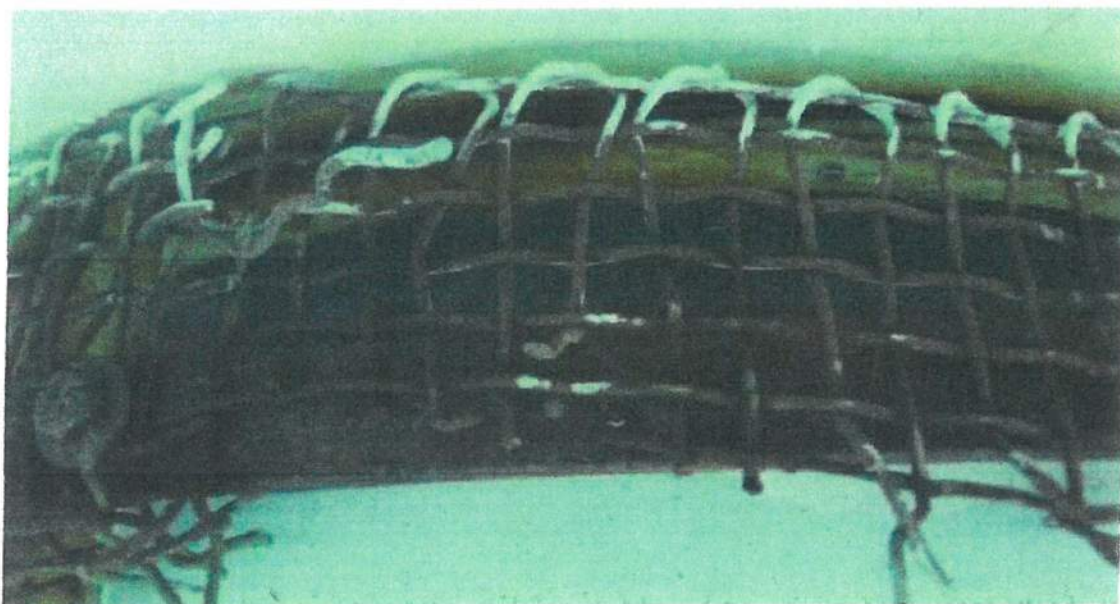
Photos show the condition of the existing 14" roof vent. **This vent is allowing the ingress of rain and wind-borne contaminants into the water system. An improperly vented tank may cause external pressure to act on the tank which can cause buckling even at low pressure differential. We recommend replacing the existing roof vent with a vacuum-pressure, frost proof vent and screen.**

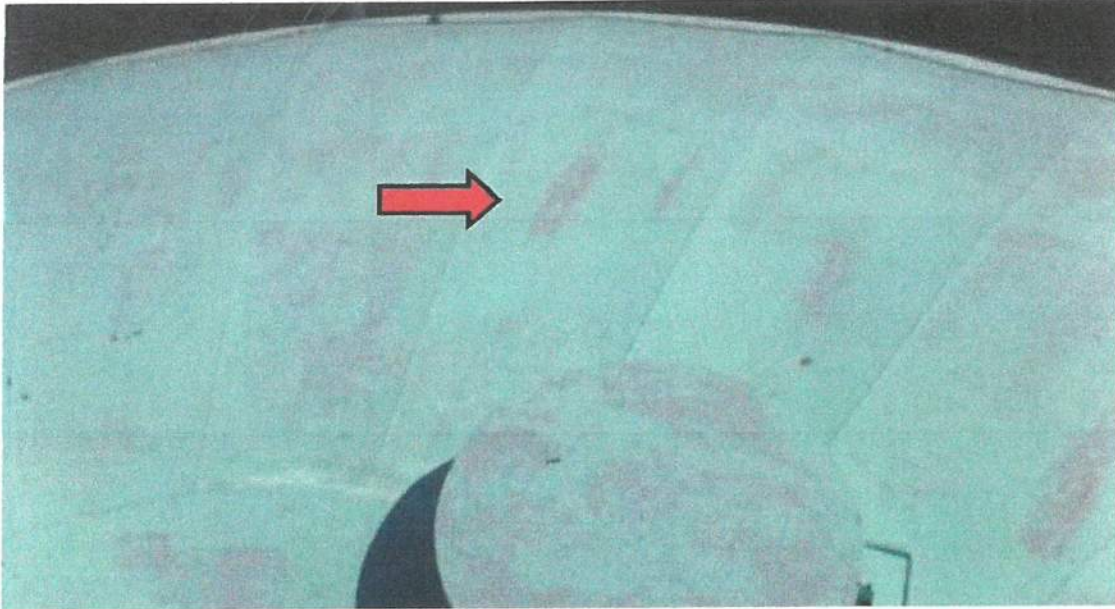
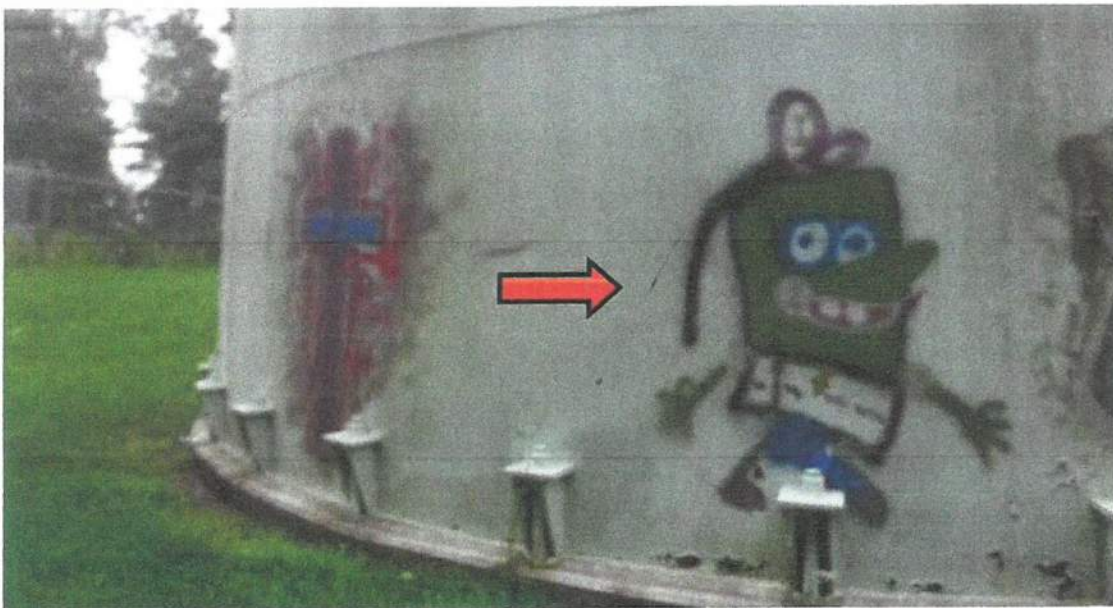
Photos show the tank exterior coating system. We recommend pressure washing the tank exterior with biodegradable detergent injection (minimum 3,500 psi at 3.0 gpm) then removing all loose rust and scale with wire brushes and hand scrapers in accordance with SSPC#2 (hand tool cleaning), spot priming and applying one (1) finish coat of acrylic paint.

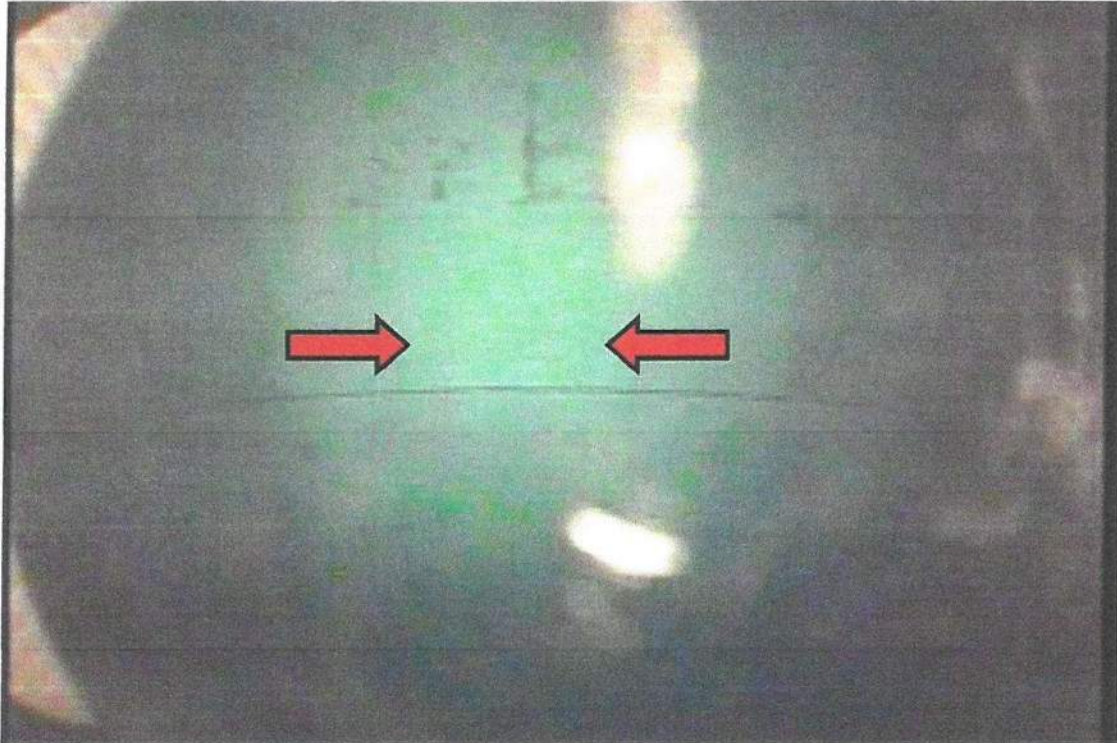
?  
Photo shows tank is not equipped with interior access ladders. **AWWA 7.4.2.4:** **Inside tank ladder** states, "When specified, an inside tank ladder shall be provided for access from the roof to the bottom of the tank." We recommend installing **OSHA** compliant interior access ladders complete with standoffs every 10' on center and anti-skid rungs, and cable type ladder safety devices at the primary and secondary roof manways.

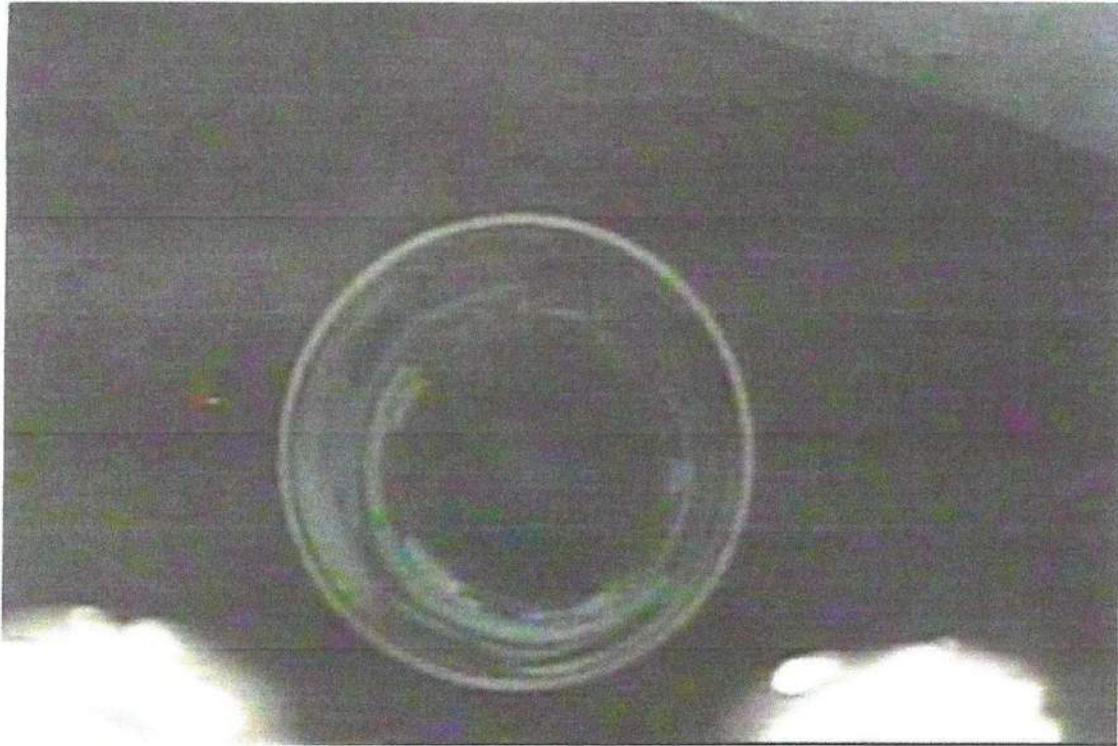
Photo shows a fill pipe on the tank interior. A temperature difference between the water in the top and bottom of a tank, even as little as 1-2 degrees Fahrenheit, is an indication of thermal stratification and the tank water not being completely mixed. Incomplete mixing would result in short-circuiting, and localized increase in water age would develop inside the tank. This typically leads to water quality problems, such as loss of residual, DBP spikes, HPC spikes, bacteria regrowth, formation of bio-film, changes in pH and dissolved oxygen. We recommend installing a mixing system.

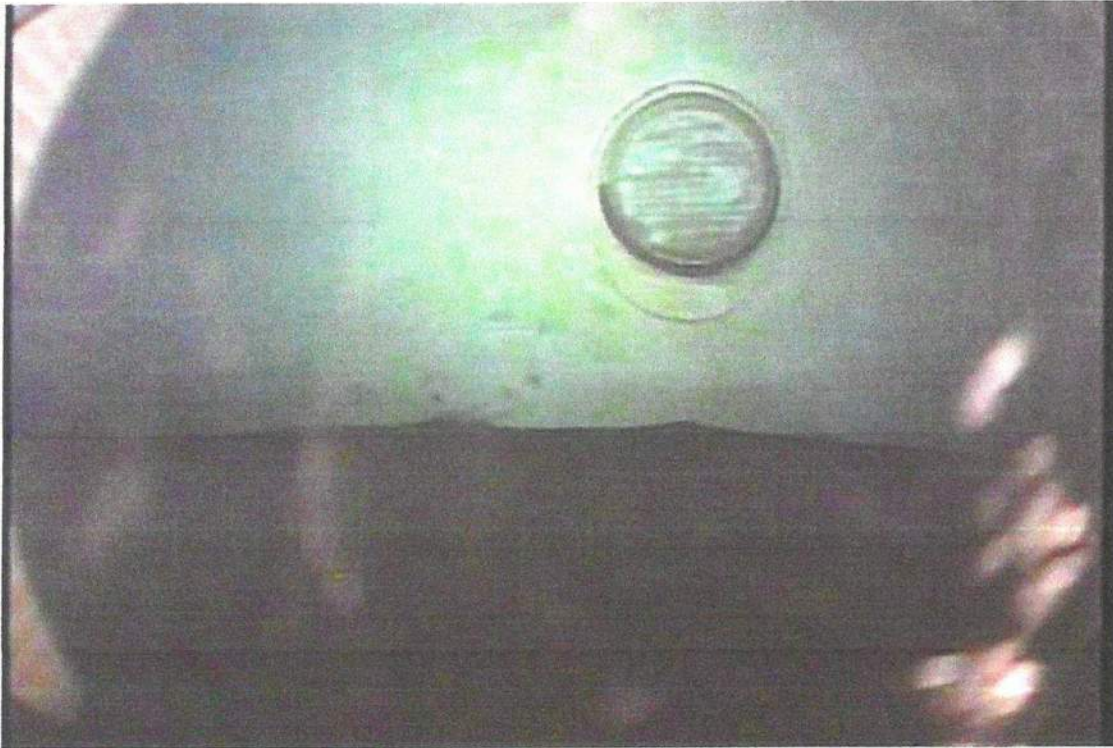
*Not clear*  
Photo shows sediment and debris in the tank. We recommend performing an interior cleanout in order to prevent contamination issues associated with excessive sediment buildup.

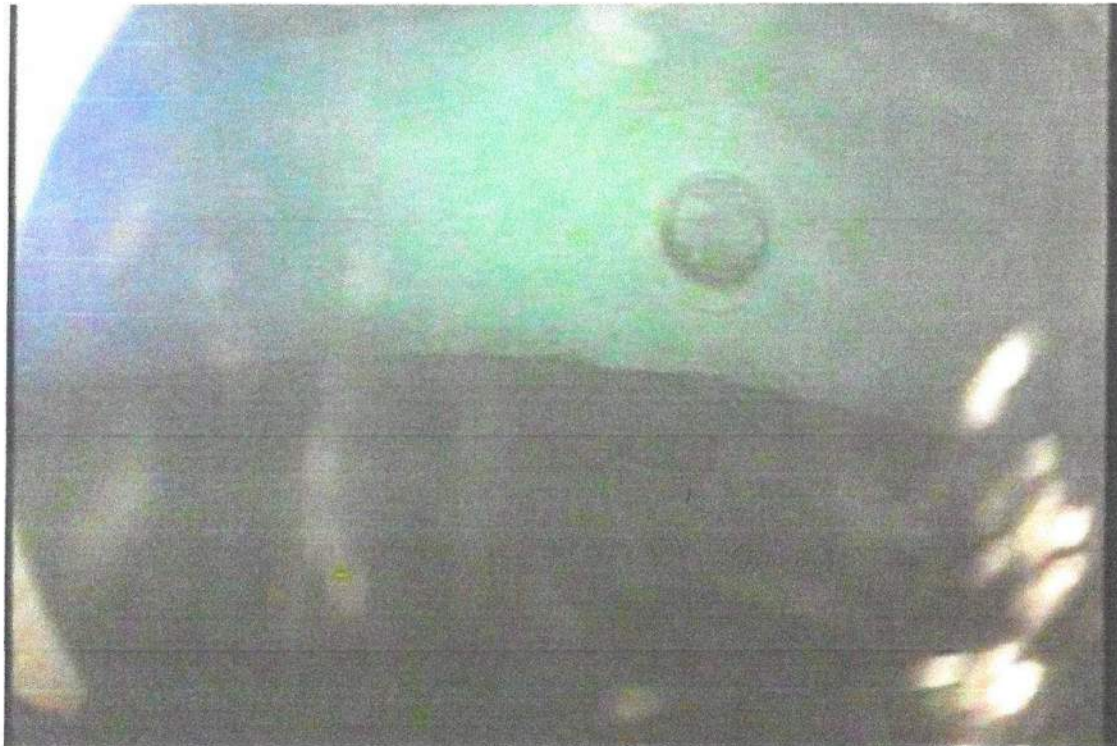
Photo shows the condition of the tank floor. After performing the interior cleanout, if buckling is present we recommend stabilizing the floor by pumping grout to the underneath side of the floor where the buckling is occurring. This will be done by installing couplings in the tank floor, pumping grout at 15# psi, filling the voided areas to prevent any further buckling, then vacuum testing the floor. Any defective seams will be repaired by welding.

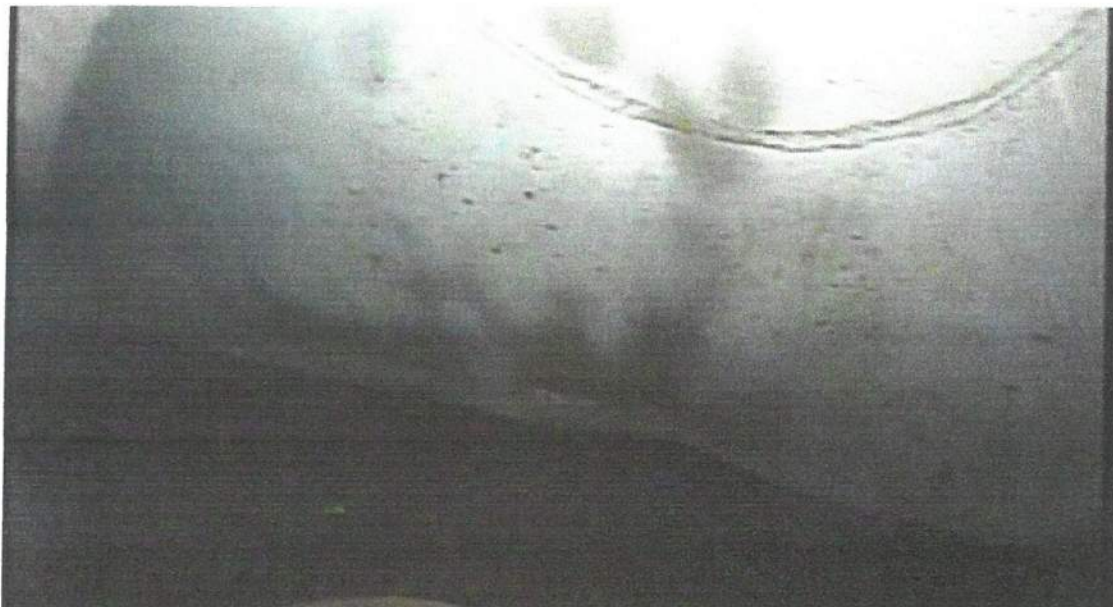
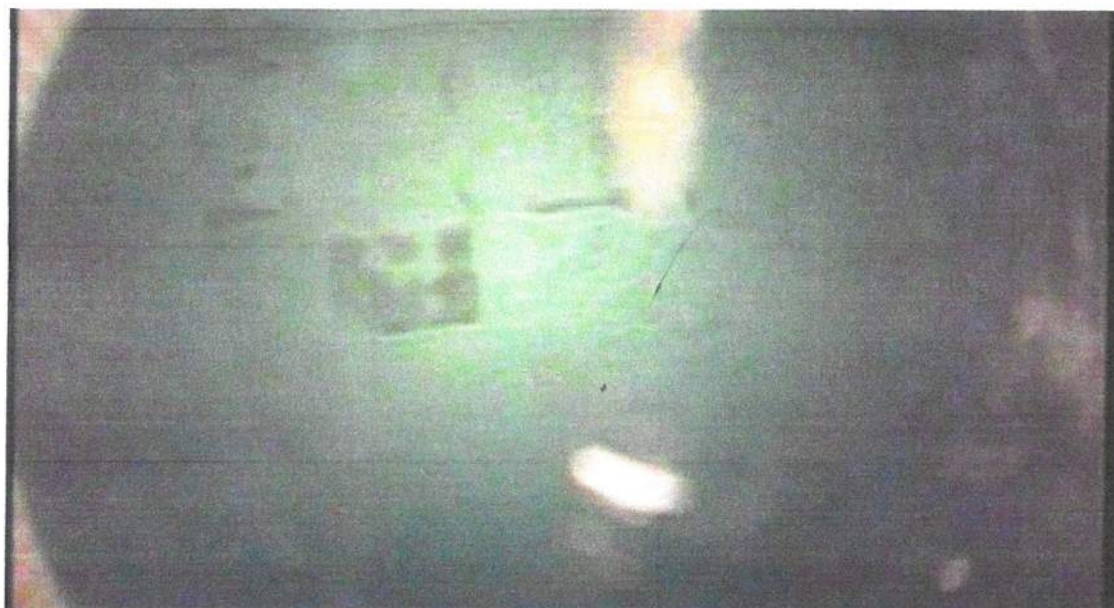
Photos show the condition of the interior coating system. We recommend sand-blasting all rusted and abraded interior areas to SSPC-SP10 (near white), and brush blasting all remaining interior areas to SSPC-SP7; then applying one (1) spot coat of epoxy primer to all areas sandblasted to #10, stripe coating all weld seams, and applying one (1) full coat of epoxy to the entire tank, to achieve 8 to 10 mils of total dry film thickness. Total mil thickness will include a combination of the existing and new coating.

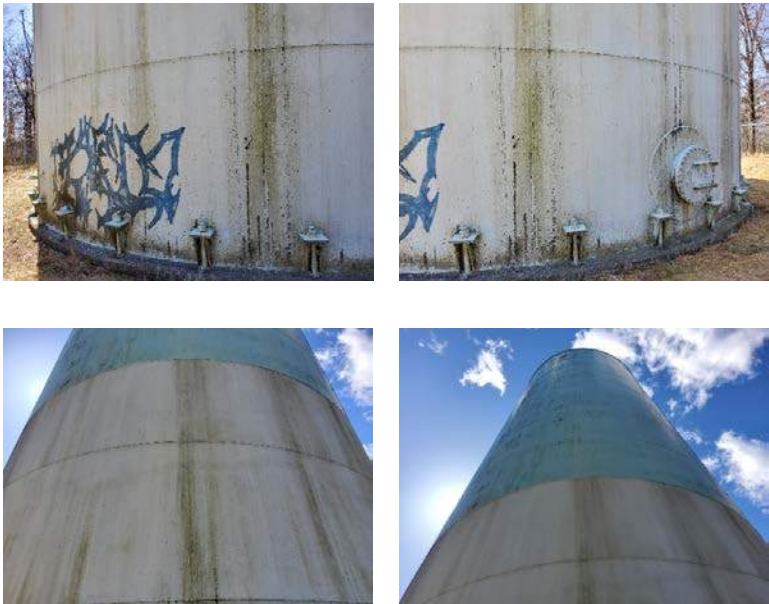
West Wall Exterior Aesthetics Photos

WEST WALL	
Aesthetics	Graffiti Mildew
Condition of Protective Coating	Decline/Thinning Peeling Delaminating
